# Smoke and Dye Testing Summary

## High Level Sewershed

Test ID	Test Type	Date Inspected	Company / Super.	Nearest MH	Ground Condition	Notification Made?		
D1028-169	Dye	4/28/2009	ADS/TM	S11GG_021MH	Dry	NA		
Address	1603 Bloomingdale Road		Location	Paved asphalt	Status	Public	Source	Storm Manhole

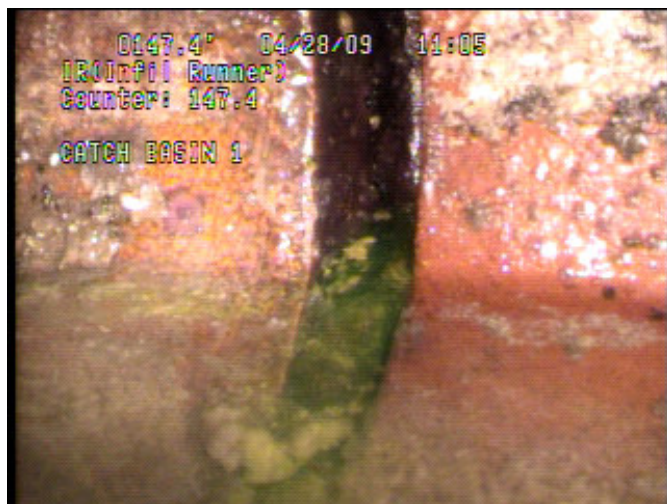
**Picture** \D1028-169-OB01-P01.jpg

**Comments** Dye observed 147.4 ft. downstream of S11GG\_021MH. Infiltration runner at joint at 5 o'clock.

**Comments** 147.4 ft. downstream of S11GG\_021MH along S11GG\_021G1.

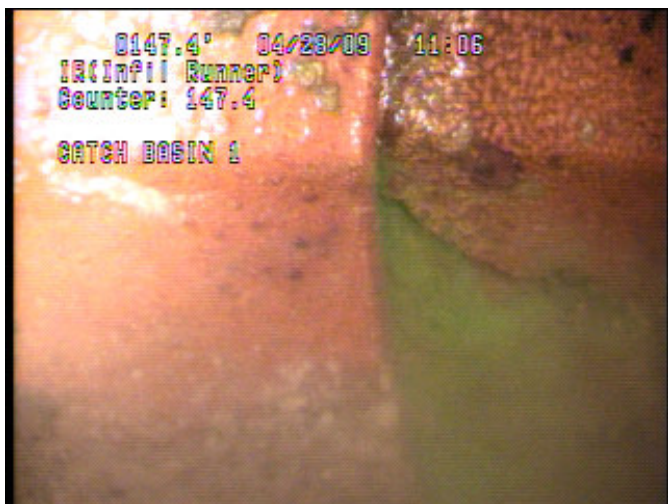
**Picture** \D1028-169-OB02-P01.jpg

**Comments** Dye observed 147.4 ft. downstream of S11GG\_021MH. Infiltration runner at joint at 7 o'clock.

**Comments** 147.4 ft. downstream of S11GG\_021MH along S11GG\_021G1.

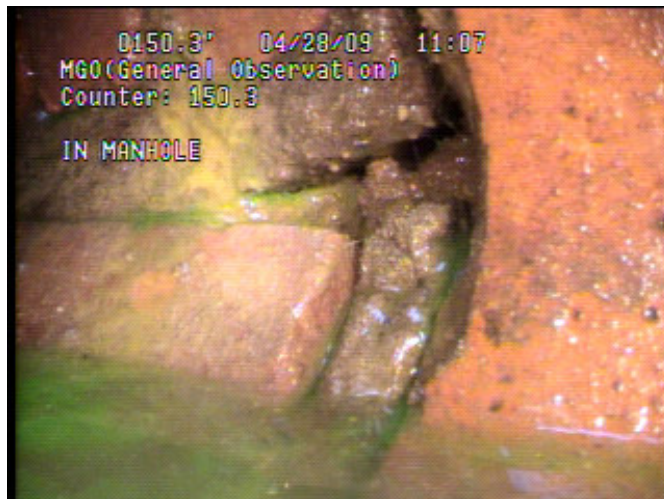
**Picture** \D1028-169-OB03-P01.jpg

**Comments** Dye observed in bench of S11GG\_040MH.

**Comments** At manhole S11GG\_040MH.

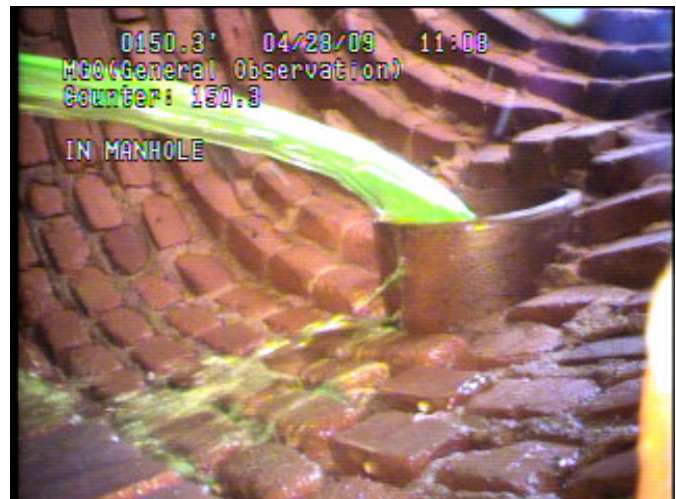
**Picture** \D1028-169-OB04-P01.jpg

**Comments** Dye observed from pipe in wall of S11GG\_040MH.  
Possible connection of storm drain to sanitary sewer.

**Comments** Pipe in wall of manhole S11GG\_040MH.
